Window Wars: Quartz vs. Titanium

National Institute of Standards and Technology (NIST)

Center for Neutron Research (NCNR)

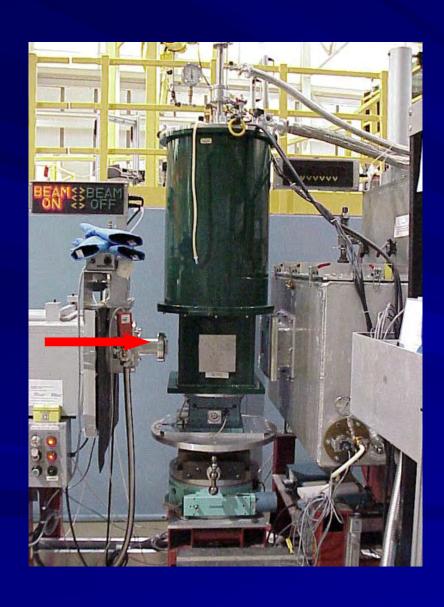
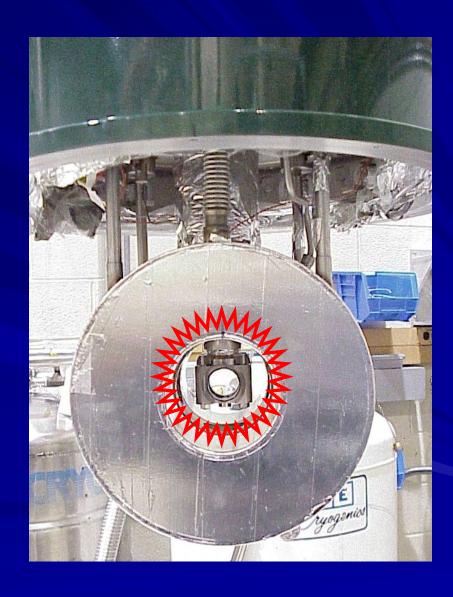
The Cryostat and Magnet

- 9T Horizontal Field Magnet for use on SANS
 - Specifically the neutron window at the bottom of the sample well
 - The cryostat and magnet
 - The original design using sapphire windows
 - The same design but with titanium windows
 - A new quartz "cup" design
 - The how and why we moved between the three
 - Conclusions

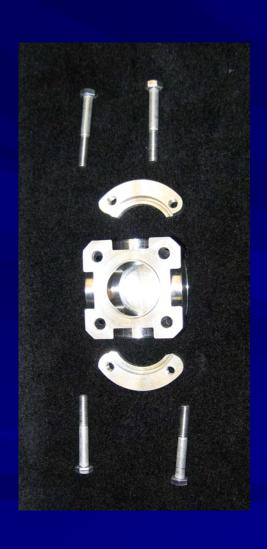
Clamp Modification

- Caused by stress from bolts
- Modify assembly to:
 - Make indium seal with less force
 - Prevent stress fracturing epoxy seals
- 2 S.S. clamp / 4 Al screw assy
- Outcome:
 - Windows still leaked
 - Easier installation though

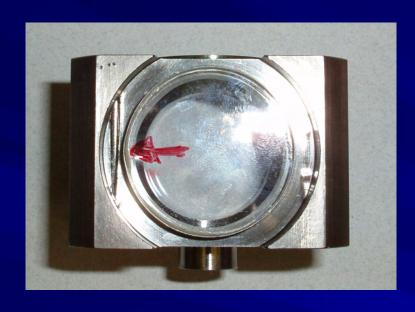
Titanium Time

- Ti block damaged from multiple "repairs"
- Windows would not seal
- Current assembly was scrap
- Requirements for new design:
 - More robust sealing method (or no seals at all)
 Acceptable window material
 Manufactured in-house

- Low risk design for now
- Solution:
 - Ti windows welded into the current Ti body

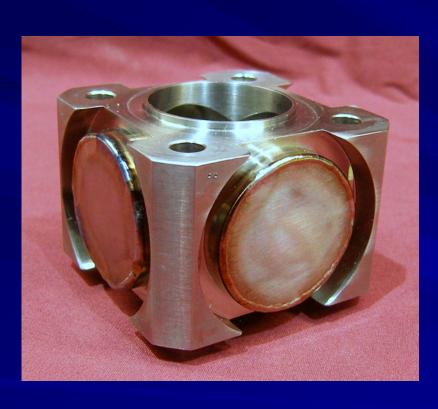
The Short Term

Design Features:

- 0.88 mm thick Grade 5 Ti
- Welded directly into original
 Ti body
- Same clamp design
- Extremely robust
- Implemented quickly
- Ti was shown to be acceptable on SANS
- It worked!

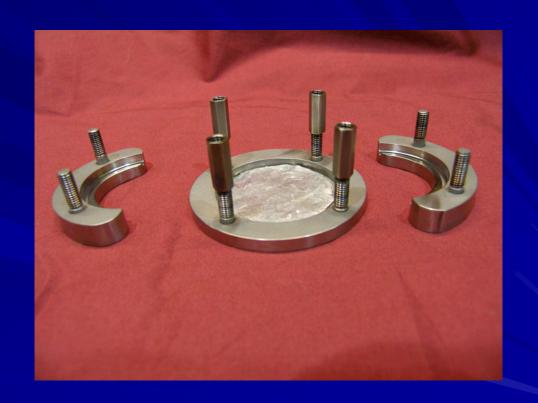
Final Touches

- Indium sheet under quartz cup
 - Smooth surface
 - Thermal contraction
- Slight modification to indium support ring

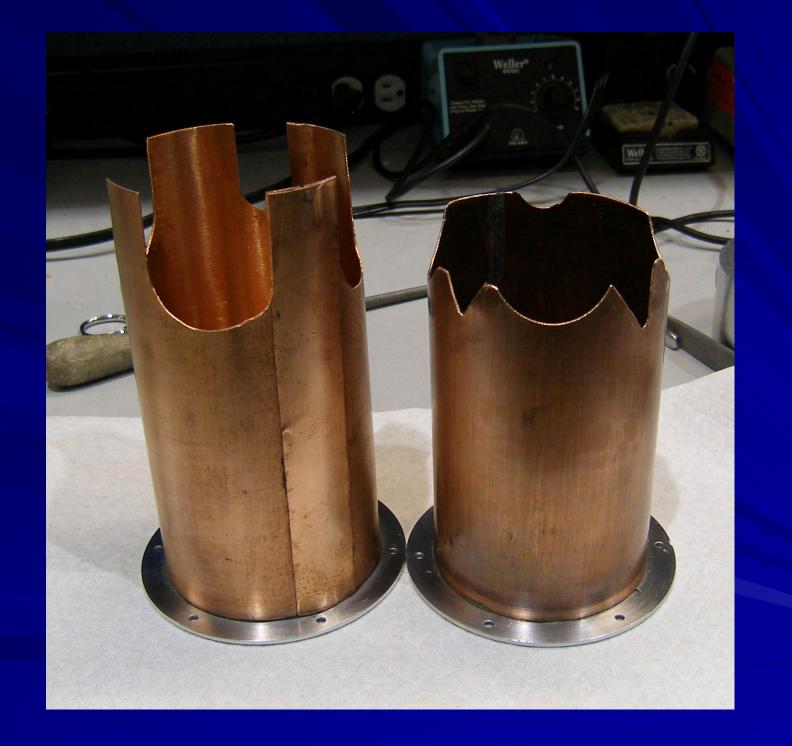
- Installation tedious, but simple
- LN2 shields were only casualty
- Leak tight through first cooldown to 2.9K
